Restoration and Modernization of Ontario's Legislative Building

A Need for Rehabilitation and Preservation

LEGISLATIVE ASSEMBLY
OF ONTARIO

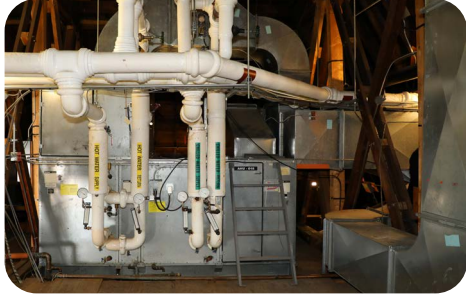
Steam radiator heat is difficult to regulate, areas are too hot or too cold.

Current HVAC units in the attic. They are close to the end of their lifecycle and need to be replaced.

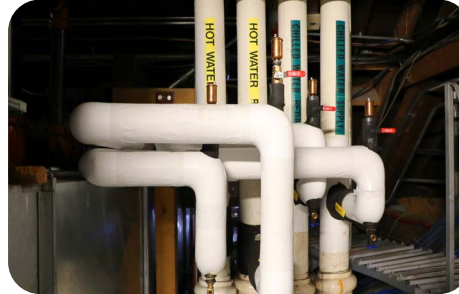
Steam pipes in the attic. Steam heat is inefficient and problematic in the summer months. Steam heated radiators overheat the building during the winter months.

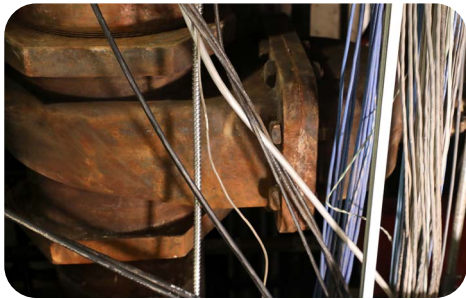
- Much of the drainage piping in the building is original. Pipe ruptures cause water damage and costly repairs.
- Interconnected storm and sanitary drainage systems do not meet current regulations. Drainage often backs up during rain storms causing internal flooding and damage.
- Lead pipes make drinking water unsafe.

Original pipes located in the basement ceiling. This would cause severe disruption as surrounding infrastructure would be impacted to undertake necessary repairs.

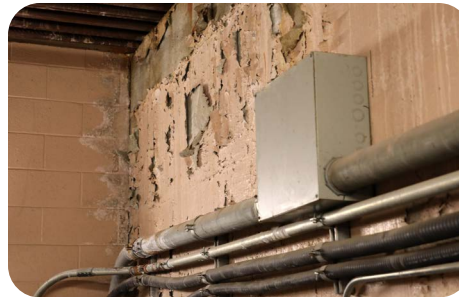
Pipes located in the basement. Leaks and flooding are prevalent with the current pipes.

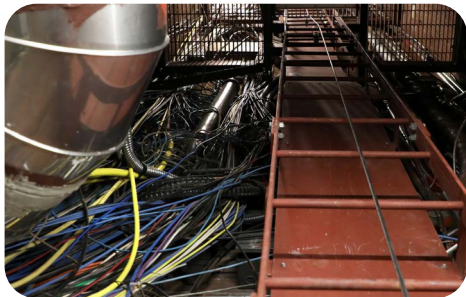
- No plan was implemented when electrical cabling was introduced, resulting in severe disorganization.
- The demand for modern services is high, and with the lack of a power and cable management system, any new additions are difficult to administer.
- There is a large amount of redundant and old cabling. It is difficult to discern which ones are in-use versus obsolete.

Cables located in a ventilation shaft in the basement. Redundant cables are difficult to find amongst the mass of wiring.

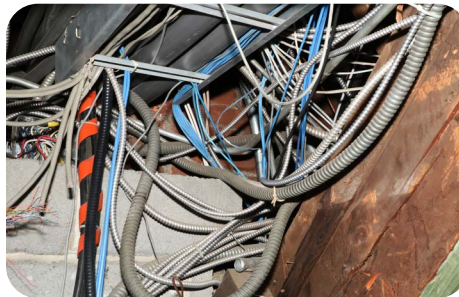
Cabling in the attic. Capacity of existing cable trays and pathways is greatly exceeded.

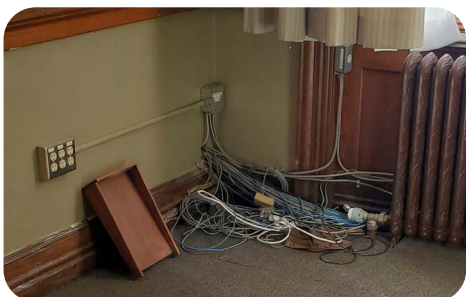
- There is limited and insufficient power supply in some areas.
- There are no consistent lighting levels in the building. Some areas are very dark which is a safety concern.
- There is a lack of supply, consistency and organization of emergency power.
- Due to outdated technology, it is currently not possible to monitor and manage all systems remotely.

Exposed wiring in an office. Insufficient power and outlet locations and lack of cable distribution pathways have led to an overabundance of wiring in offices.

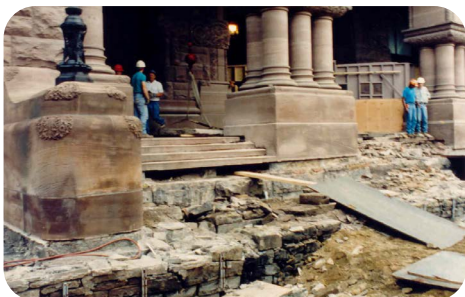
- The stonework and masonry are continually degraded by environmental conditions. Ongoing maintenance is required.
- As a result of further weathering, masonry restoration took place during the 2010s.
- The foundation was excavated to improve drainage and help prevent water infiltration.

Extensive restoration of the exterior masonry and major modifications to the main entrance in the 1990s. As sandstone is a soft stone, it erodes very quickly.
